10. PERMAFROST

Thomas E. Osterkamp, Geophysical Institute, University of Alaska Fairbanks

10.1 Introduction

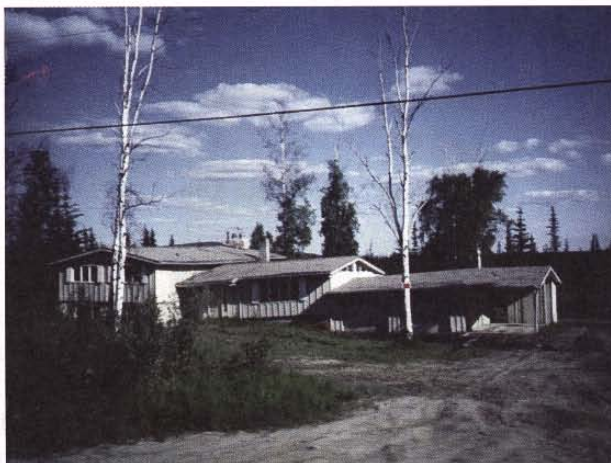
Figure 10.1. This house damaged by thermokarst in the Fairbanks area had to be abandoned.

- ◆ Abandoned and damaged houses in Alaskan communities (Fig. 10.1).
- ◆ Abandoned building at a radio transmitter site near Fairbanks.
- ◆ Abandoned hospital in Kotzebue.

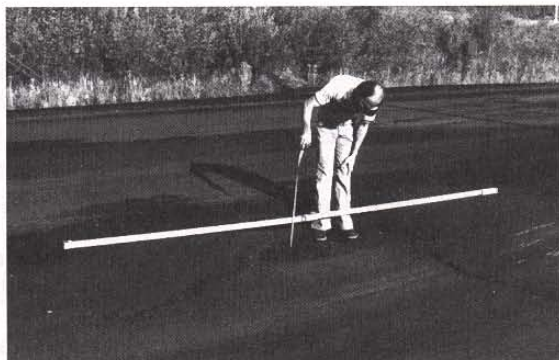
Figure 10.2. Thawing of ice-rich permafrost and the resulting thermokarst caused this road to settle which required repeated patching to keep the road in service.

- ◆ Abandoned and damaged roads and bridges (Fig. 10.2).
- ◆ Specialized and more expensive construction methods for roads, airports, pipelines and other structures (Fig. 10.3).

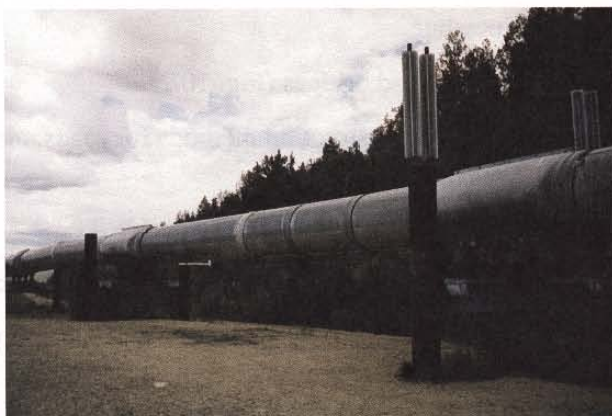
Figure 10.3. Trans-Alaska pipeline showing the above ground portion of the pipe supported by naturally refrigerated pilings. This expensive construction mode was required because of the presence of ice-rich permafrost which had to be kept frozen.

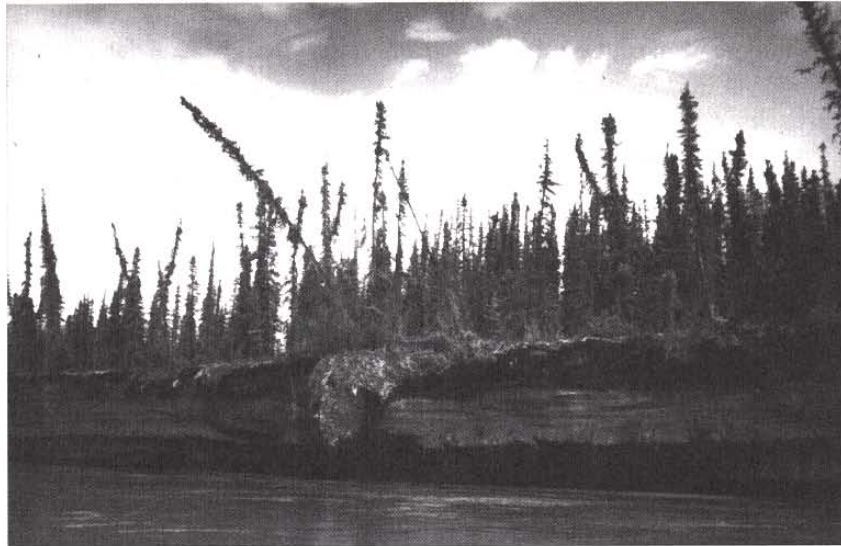
Figure 10.4. This river bank in ice-rich permafrost has been undercut a distance of several meters. The bank will eventually collapse putting trees, shrubs, organic material and large volumes of silt into the river increasing the sedimentation problem.

- ◆ Thermokarst damage to agricultural fields.
- ◆ Increased sediment loads and siltation in rivers (Fig. 10.4).
- ◆ Destruction of trees in the boreal forest (Fig. 10.5).

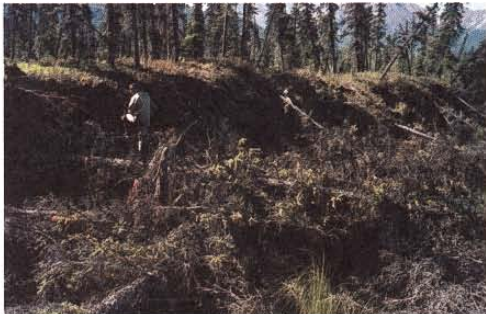
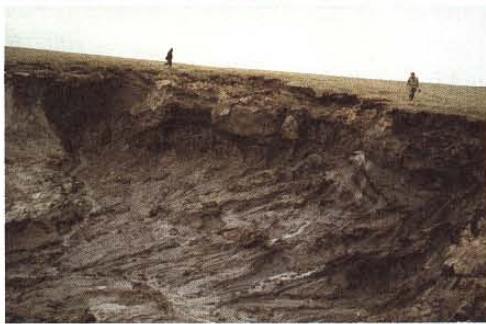
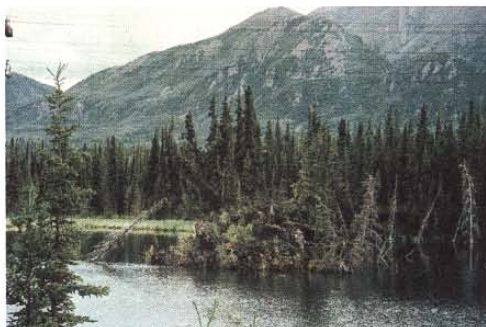
Figure 10.5. Examples of how existing ecosystems have been destroyed and are being replaced by new ecosystems as permafrost thaws:

- a. Active thermokarst that is altering the boreal forest near Tok, Alaska, in an area of warm, discontinuous permafrost;
- b. Active thermokarst in an area of continuous permafrost on the Gydan Peninsula, Russia;
- c. An active thermokarst that has resulted in a pond. More than 5 m of vertical settling occurred. Note the dead trees in the water and tilted trees on the island, indicating that settling is still in progress (photos by Tom Osterkamp)

- ◆ Ecosystem damage and destruction such as that occurring in the Tanana Flats, Mentasta, Healy and Cantwell areas (Fig. 10.5).
